Renovation of Heritage Assets using BIM: a Case Study of the Durham Cathedral

Abstract

2. Case Study: Durham Castle and Cathedral

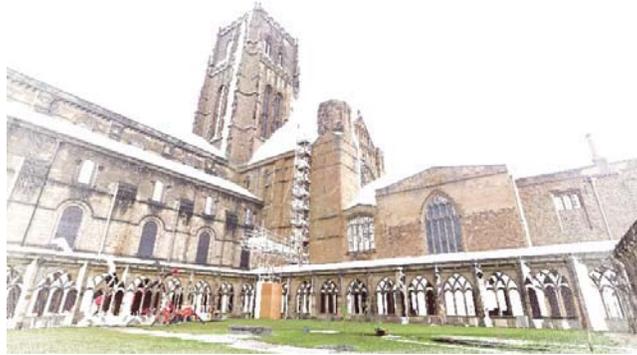
Figure 3 Point Cloud of Durham Cathedral's grounds

The first step was to capture as-built conditions of the Durham Cathedral prior to starting the modelling process. 3D Laser scanning was chosen as the method to survey the building. Scanners can differ in: scan radius, scanning speed, accuracy of the scan as well as the weight/portability, but mostly work on the same principal. A laser scanner emits a rapidly pulsing or continuous laser beam towards the area being scanned. The laser scanning unit distributes the laser beam both vertically and horizontally, resulting in a systematic sweeping of the beam over the surrounding area. When a beam hits surrounding objects, some of the energy bounces back to the scanner, where if the returned energy signal is strong enough, the unit detects it and a timer uses it to calculate the distance from the scanner to the object. For each distance measurement, the corresponding horizontal and vertical angles of the rotating laser are calculated and used to acquire precise 3D X, Y and Z coordinate positions for each point.

way. Prior to starting the laser scan process, appropriate calibration of the unit needs to be undertaken to maintain maximum accuracy. The unit used for Durham Cathedral had an overall tolerance of ± 50 millimeters, which was very adequate for the accuracy of subsequent 3D modelling. Some areas of Durham Cathedral such as the tight circular staircase were hard to access with the laser scanner. However, more versatile and less expensive handheld scanners could have been used in this area but this would have affected the accuracy of the scan, the size of the object being scanned and the time to complete the scan. The resulting scan of the Cathedral was a 250 million point scan that resulted in a model size of 8 gigabyte and highly accurate measurements of the site (typically to a few millimeters), as well as a record of the intricate detail of the site's current condition (Figure 3). However, this is simply a detailed 'dumb' 3D representation, which needs to be enriched with information to become an intelligent model that supports decision making of the asset renovation.

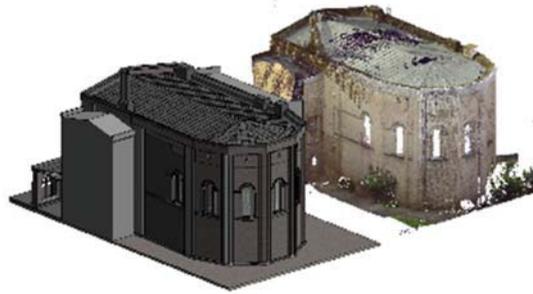
Figure 4 3D model created from Point Cloud scans

Prior to modelling, the Point Cloud was then imported to Autodesk Recap, where it was manually purged to eliminate their interference, leaving only the room. The Recap model was then linked into Autodesk Revit, where the procedure of creating the geometric model was through tracing over the Point Cloud. For modern buildings, the standard modelling tools can be used to quickly create objects such as straight walls/ceilings with the object-specific parameters embedded. However this was not always possible in historic buildings due to the unique nature of the heritage assets. The examined building has irregular shapes and standard modern tools cannot be used to accurately represent its slanted structures. Therefore, the Generic Model tool was used for those areas, which allowed the creation of bespoke components that are as realistic as possible, and then manually adding any object-specific parameters to it. The choice of whether or not to use the Generic Model tool can be determined by the future use of the model. If it is for purposes that do not require high-accuracy representations, then the standard tools could suffice which are less time consuming. After creating the geometry which defines the structure, the model was populated with parametric data resulting in a data-rich 'intelligent' model. This included condition information of the structure and traditional outputs such as elevations, sections and floor plans (Figure 4).

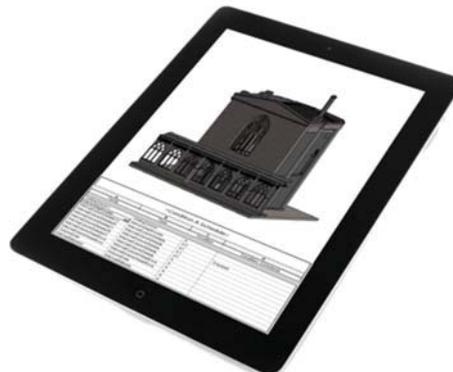
Figure 9 Utilize the model on-site via mobile technology

- Provided remote and convenient access to information and models with the support of mobile technology (Figure 9) to e.g. explore and update the model on site and create surveys and reports.
