# A CASE STUDY ON COMPARATIVE ANALYSIS OF 3D POINT CLOUDS FROM UAV MOUNTED AND TERRESTRIAL SCANNERS FOR BRIDGE CONDITION ASSESSMENT

**Abstract:** Recent improvements in 3D laser scanning technologies enabled accurate capturing of existing spatial conditions using point clouds. To leverage this progress for a more accurate condition assessment, state Department of Transportations (DOT) across the US have been utilizing scanning technologies through deployment of terrestrial laser scanners (TLS) and more recently Light Detection and Ranging (LIDAR) scanners fitted to UAVs. However, not much study thus far discusses the potential of these 3D point clouds captured from these two different data collection approaches for supporting automatic and detailed (element-level) condition assessment of bridges. The goal of this study is to compare the utilization of 3D point cloud generated from a terrestrial scanner with that from a UAV in supporting element-level condition assessment of bridges. This paper presents recent results from full scale deployment on a small/medium size highway bridge. An important component of our effort is to explore how well the collected data supports element leve

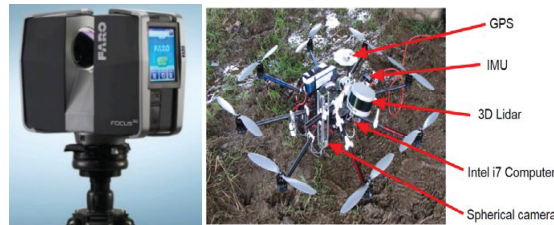
Figure 1: Figure depicting scanners (a) TLS (b) UAV

To collect scan data for this study, we used a medium range commercially available phase-based scanner as the TLS option, whereas the UAV has been fitted with state-of-the-art sensors that are required to enable both, mapping and localization. Figure 1 shows pictures of both scanners and Figure 2a shows scanner locations and representative flight paths during data collection of this bridge. For data collection, our goal was to position the TLS in a manner to ensure capturing maximum amount of visibly exposed bridge element surfaces. With similar data collection goals, UAV path included at least one pass under each bay of the superstructure. The data collected by TLS are stitched together using feature-based registration process, whereas the UAV scans are timestamped as they are being captured, and on-board processing capabilities on UAV are leveraged to register these scans. Overall, the size of the point cloud from TLS is about 12 million points. On the other hand, the point cloud from the UAV scans had approximately 4.8 million points. The top view of Span 1 in these registered scans is given in Figure 2b.
