INSTRUMENTATION OF BURIED FLEXIBLE CULVERT SUBJECTED TO ROCKFALL LOADING

Roger Ebeltoft¹, Jan Otto Larsen²

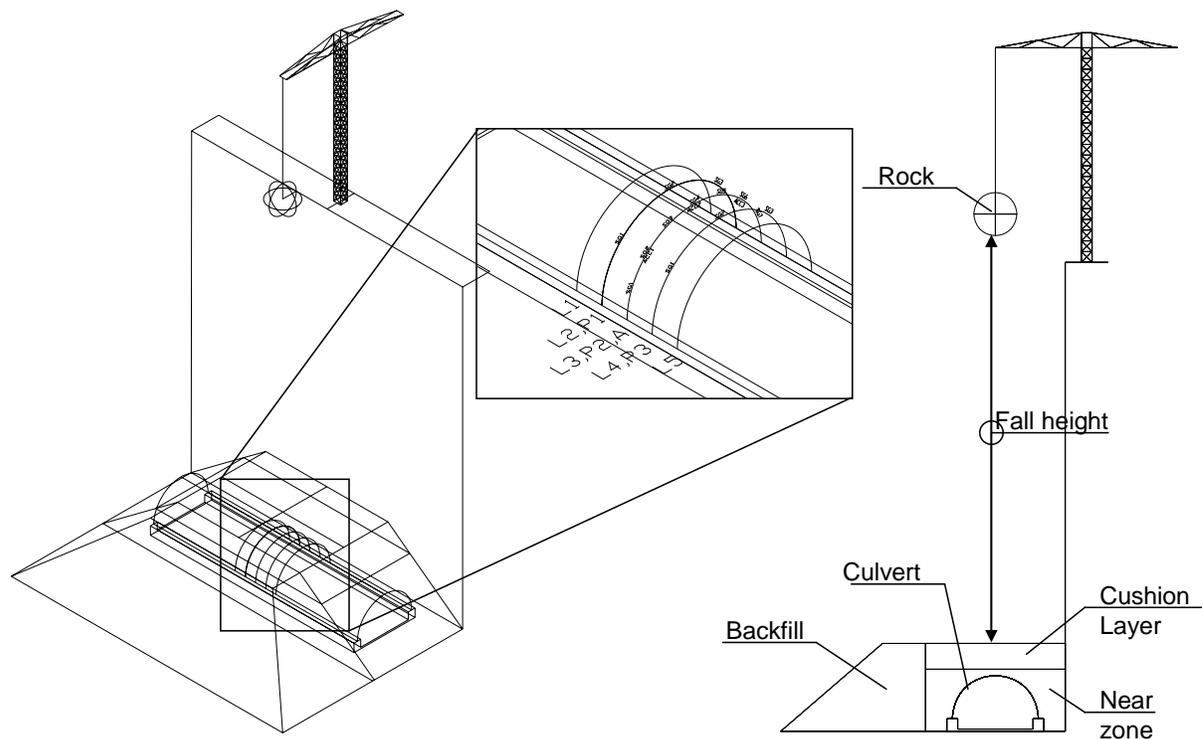
The 15.0 m long structural plate metal arch culvert was installed on a reinforced concrete plate foundation, Figure 1. 80-200 mm size compacted gravel was used as backfill at the ends.

The MP200 Arch type metal culvert (Asset International, 2002) was used, which is a galvanized corrugated circular steel arch with a 4.00 m span at the foot and a 1.93 m total rise. The culvert was manufactured from structural plates with 200 x 55 mm corrugations. The plate thickness was 5.0 mm.

The culvert was backfilled. Backfill material in the near zone consisted of 8-16 mm gravel. The outer zone consisted of 23-64 mm size gravel. Confinement of the gravel consisted of rock surface on one side and an 80-200 mm size gravel on opposite side.

During the construction sequence backfill material was placed in 300 mm thick layers and compacted. This procedure was commenced until 300 mm above crown. Rest was placed in 600 mm layers without compaction.

Figure 1: Illustration of experimental setup

After completion of installation impact load tests were conducted. In present study, natural rock boulders have been used, and the impact of these rocks are centered above the crown of the culvert. After each impact test the cushion layer was removed and replaced to same level. Figure 1 represents the experimental setup.

Three accelerometers were installed inside the culvert to measure transmitted accelerations. The accelerometers used were PCB Piezotronics model 353B03. These were installed at profile A, as shown in Figure 1.

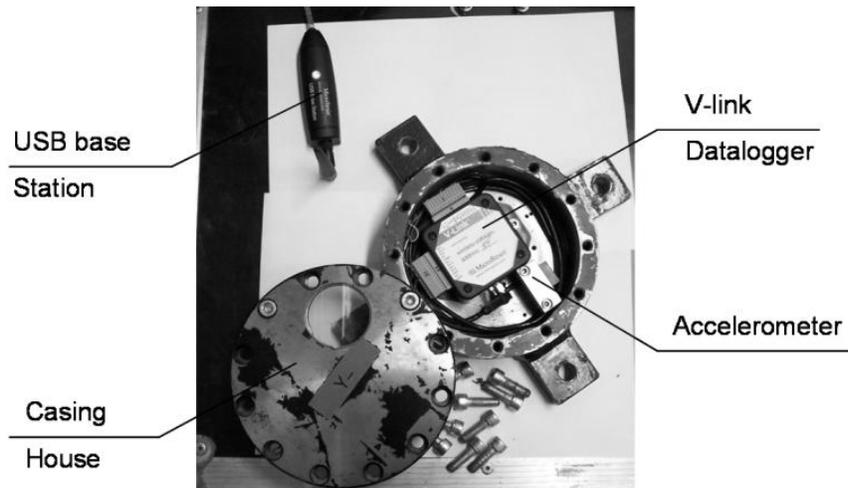
Figure 2 shows the accelerometer device that was fitted with a wireless MicroStrain V-link data acquisition system. The accelerometers used were IC Sensor model 3031-100. Each rock block was successively equipped with this device to measure the deceleration history in three directions.

Figure 2: Device used to acquire deceleration history of rock impact

The signals from the accelerometer mounted on the rocks were acquired with the wireless MicroStrain V-link data acquisition system (Microstrain Inc, 2004). A sampling rate of 2048 Hz was used.

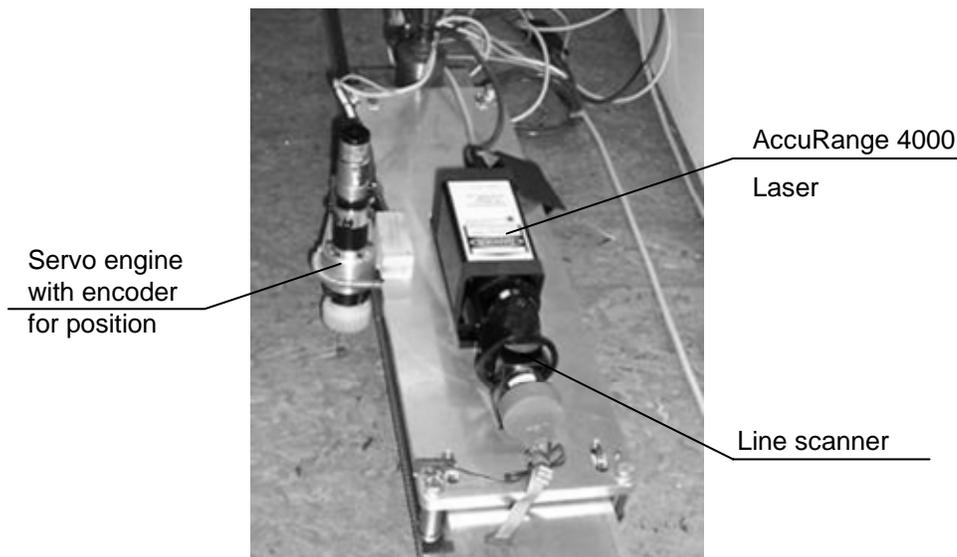
Figure 3 shows the laser device, AccuRange 4000 equipped with a rotating line scanner, which was mounted on an automated wagon to obtain deformations while construction and during the impact tests (Webb et al., 1998). During construction, after placement of each layer, the laser wagon was used to monitor the profiles L1-5 as described in Figure 1. The electrical servo engine had an encoder that ensured the position of the laser device in the longitudinal direction. After impact tests the laser device was also used to monitor the same profiles to detect permanent deformations of the culvert.

Figure 3: Laser device mounted on wagon. Used inside the tunnel to obtain deformation of culvert

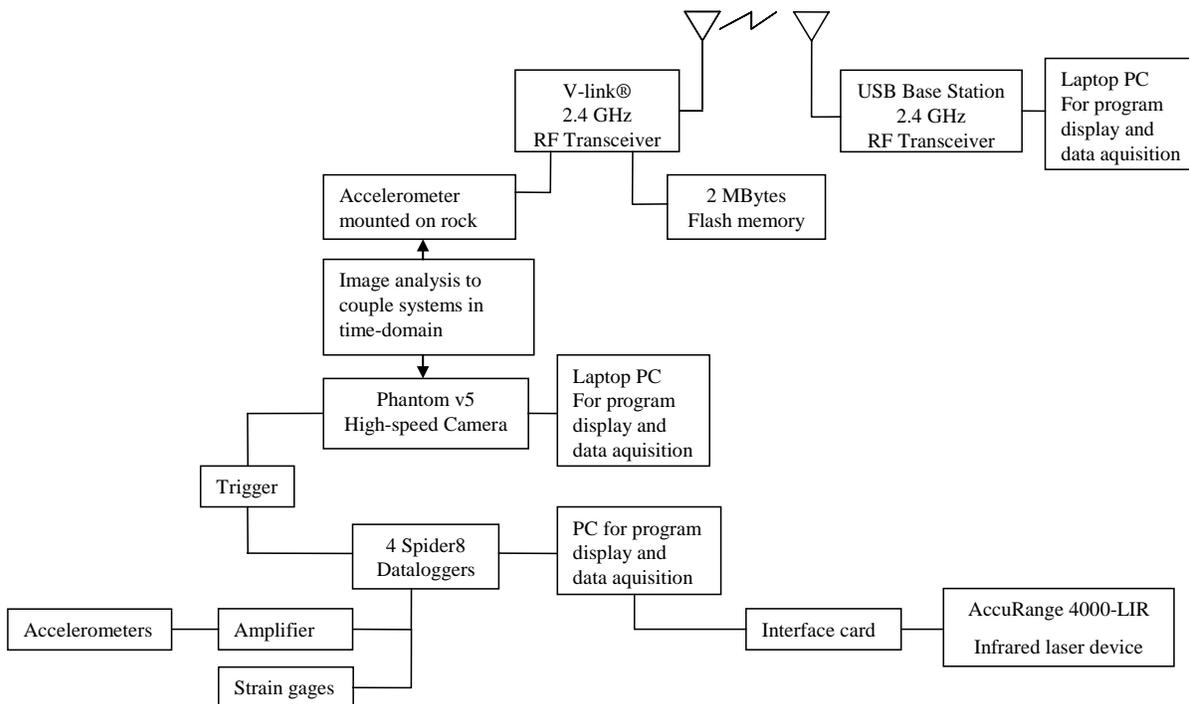
The signals from the accelerometers were conditioned with PCB signal conditioner model 482A22 and readings from strain gages mounted inside the culvert and from the laser device (Aquity Research, 2004) were acquired with HBM amplifier type Spider 8 and measurement software Catman Pro (HBM, 2005). A sampling rate of 1600 Hz was used.

A trigger system ensures that the high-speed camera, the accelerometers and strain gages were started simultaneously. Due to the independence between the V-link acquisition system and the Spider 8 acquisition system, image analysis was performed on the high speed images to correlate the deceleration history of rock and the rest of the system.

Figure 4: Schematic layout of data acquisition system

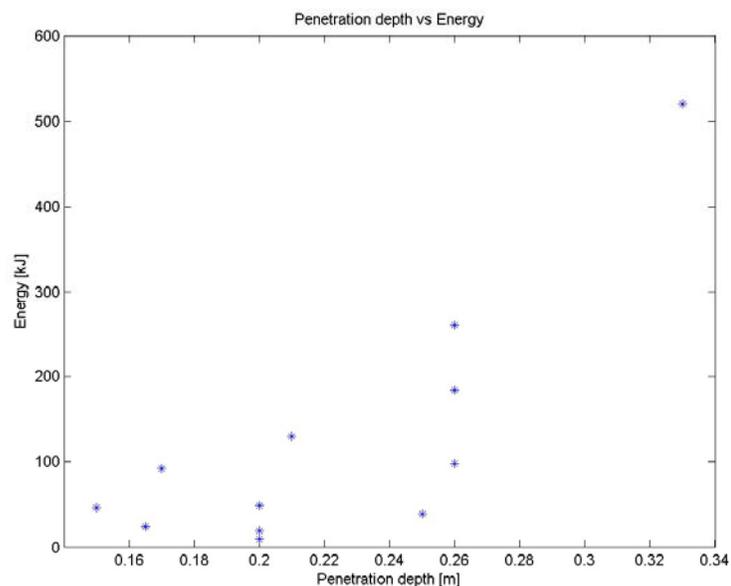
Figure 5 present observed penetration depths while rock fall testing. Penetration depth was measured by means of a stadia rod. As shown in figure the penetration depths (15-32 cm) is increasing with the increasing mass and fall heights. This also indicates high energy dissipation with increasing impact loading.

Figure 5: Penetration depth vs Energy for rockfall tests with rock masses of 200, 500, 938 and 2650 kg. Fall heights varying from 5, 10 and 20m

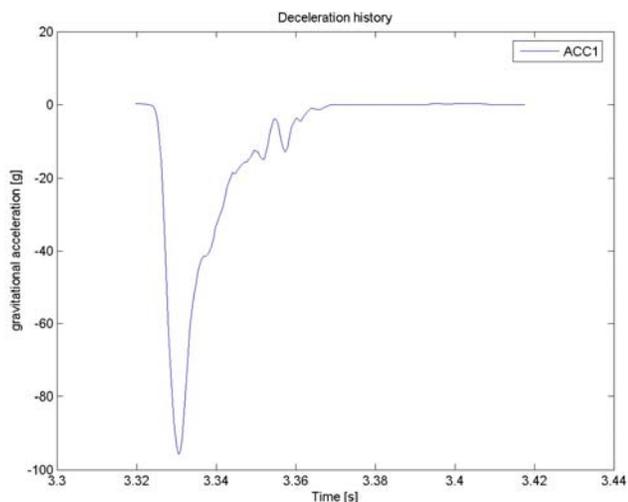
Figure 6 present a typical vertical deceleration history from the rockfall impact. Duration of this impact is in the order of approximately 40 ms.

Figure 6: Typical deceleration history of low-energy rockfall impact

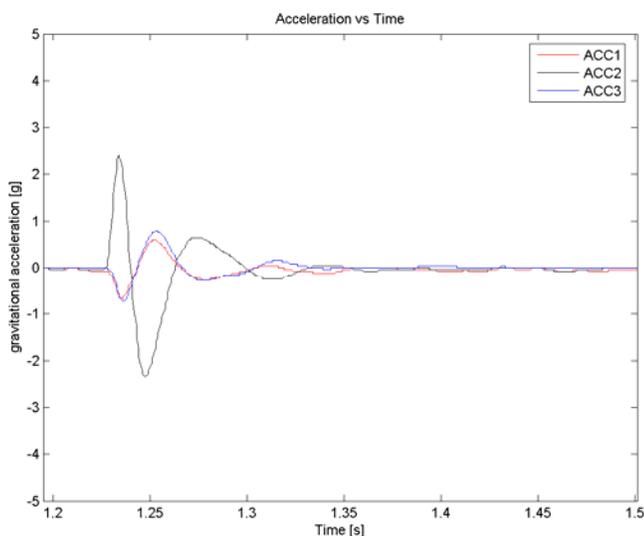
Figure 7 show a typical measurement of transmitted accelerations occurring in the culvert during impact. The figure shows that the impact load generates downward accelerations at the crown (ACC2) of the culvert, and outward accelerations for the other accelerometers (ACC1 and ACC3). The impact generate an oscillation that is highly damped and lasts for only about 100 ms. The energy of the impact is in part absorbed by the soil cushion and in part transmitted through the soil and the structure to the surroundings.

Figure 7: Accelerations for the culvert at profile S2 during impact

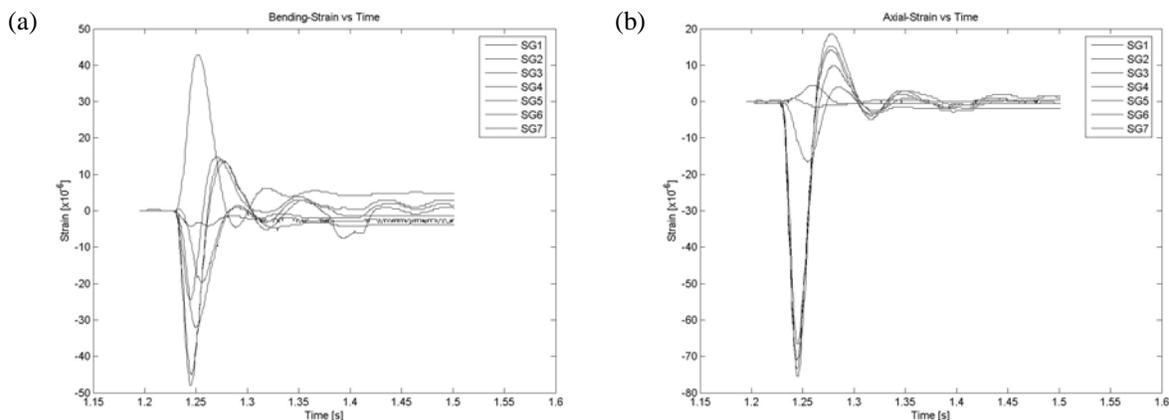
Figure 8 shows a typical measurement of dynamic strains during a low-energy impact. Initial strains during construction phase have been reset to zero. Result shown in Figure 8(b) describe that most of the structure is compressed during impact except at the crown where it shows tensile behavior. Figure 8(a) show bending strains during impact where positive strains are inward bending, while negative strains are outward. This is characterized as a small depression at the crown, while the sides are deflecting outward.

Figure 8: (a) Bending strains for the culvert at profile P2 during impact and (b) Axial strains for the culvert at profile P2 during impact
