**Data Collection System for a Rapid Recovery Work:
Using a Digital Photogrammetry and a Small UAV (unmanned aerial vehicle)**

Photog-CAD® is software to aid prompt operations from conducting surveys to making designs and estimated expense for recovery in the collapsed area of slopes and river revetments caused by natural disaster. This software is intended to make a design and an estimate based on the 3D models created by processing pictures of the collapsed site from three directions using a close-photogrammetric technique. However, when taking pictures from the ground, there are many restrictions which often make the use of this software difficult. This research paper proves that it is efficient to use an unmanned aerial vehicle (UAV) which can take photographs from the sky above, and reports a case study in which we efficiently conducted a survey using Photog-CAD® with the UAV, and made a design, estimate, and documents for the budget request.

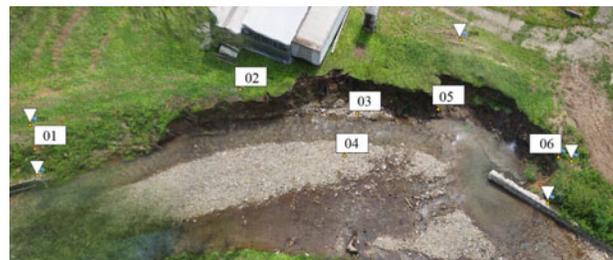
Figure 5. Reference points and inspection

When pictures were taken from three directions from the ground in this site, it was impossible to capture the flat area on the top of this site and the collapsed area in the back side of a retaining wall block. Therefore, creating 3D data and a cross-section view was impractical. To solve this problem, we took pictures from above using the UAV. The camera which was mounted on the UAV was a digital single-reflex camera with the image stabilizing system with 14mm focal length, which is equivalent to about 28mm for a 35mm full-framed camera. The camera was set to automatically shoot a picture every two seconds to fully utilize the performance of the software which can instantly compute a bundle adjustment from the many pictures. In this test, we used the software, “Agisoft PhotoScan”, which automatically makes exterior orientation, image correlation, and 3D data from the images taken with the UAV. It compared the positional coordinates of inspection points on the 3D model and those of reference points measured using a TS to verify the accuracy. Stereophotogrammetry has been developed by various software companies in recent years. Algorithms which can handle huge amount of bundle adjustment at high speed have been adopted. Figure 5 shows the reference points and the inspection points.

- ▽ Reference points measured by TS
- Inspection points measured by photogrammetry

Five reference points, of which positional coordinates were already known, and six inspection points were prepared. Actually, only three reference points would be enough to make a verification, however, because we use the method of least square for adjustment calculations, distributing more points into the photographic survey range in a well-balanced pattern makes the accuracy improve. This test was intended to verify the effectiveness and the accuracy of the photographic survey using a UAV, but not to make an official document for assessment of the disaster. Also, reference points and inspection points were made

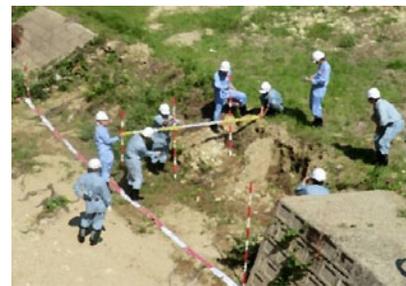
Figure 11. Conventional surveying

However, it was too difficult to recognize the targets and the photograph three-dimensionally. Therefore, we took pictures from a lower altitude to capture the disaster site divided into three pictures. It required three vertical poles to split the site into three sections, and to measure the distance between poles, and also to take three pictures of each section. However, taking the pictures took only about ten minutes, and the whole operation took just about 60 minutes, even though it usually takes much more time and work to combine the CAD drawings when a site is split into several sections. Also, this particular site has to be split into more than eight sections using the conventional method of photographic survey from the ground, because the photographing distance is too close. However, the use of the UAV made division into only three sections sufficient this time, and considerably reduced the whole operation quantity including the operation using a computer. Using the conventional method, sites like this required many surveyors to conduct cross-section surveying using poles as shown in Figure 11. Moreover it would take about five days to finish the whole process, from conducting field operations to making documents for assessment. However, the method using a UAV took just two days and two operators to complete the field operation part. Working in

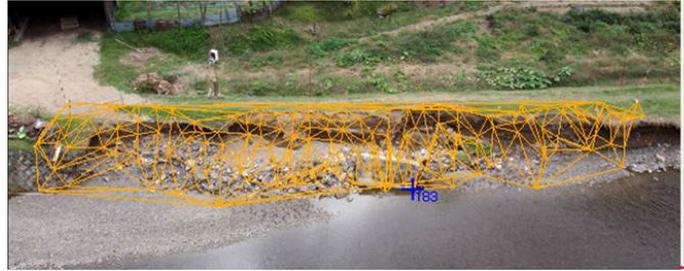
Figure 12. TIN data of the damaged site in Kyoto Prefecture

collapsed area is dangerous, therefore this test case achieved quite valuable results considering the setback of terminating field operation for a short amount of time. This post process procedure took 2 hours and 45 minutes, in comparison with the conventional method, which requires about 6 hours and 30 minutes. Moreover, this method enables inspectors to conduct a survey in more disaster sites over one day, which is more efficient. Figure 12 shows the TIN data of the section of the starting point side.
