# Enhancement of Building Façade Inspection Through AI and UAV Technology

Erhan Tarık Kurucu, Ph.D.(c) [erhan.kurucu@ozu.edu.tr](mailto:erhan.kurucu@ozu.edu.tr) [erhan.kurucu@tuvsud.com](mailto:erhan.kurucu@tuvsud.com)  
*Department of Civil Engineering, Özyeğin University, Türkiye*  
*TÜV SÜD Türkiye*

Senem Seyis, Ph.D., Associate Professor [senem.seyis@ozyegin.edu.tr](mailto:senem.seyis@ozyegin.edu.tr)  
*Department of Civil Engineering, Özyeğin University, Türkiye*

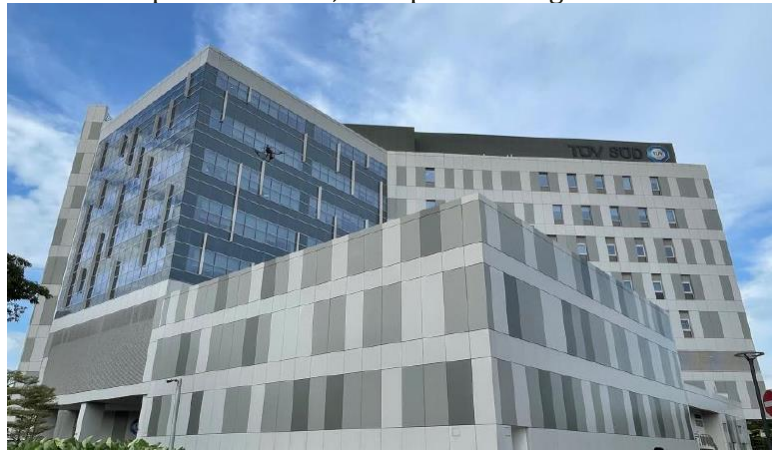
The building construction type is a reinforced concrete structure and cladding system. The cladding system is aluminum cladding and a semi-unitized curtain wall. The construction of the one block structure was completed in 2021, as depicted in Figure 1.

**Figure 1.** The building structure.

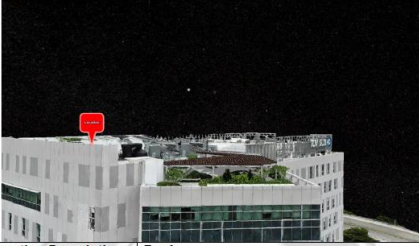
Defect Index	2
Defect Location

Defect Location Description	Roof
Defect Photo

Defect Type	Dislodgement
Defect Description	
Defect Classification	Unsafe
Recommended Action	Immediate repair required
Repair Recommendation (Refer to Appendix A)	Aluminium,

Figure 4. Defect No.1 detail depiction (unsafe).

In the report, defects of visual inspection by drone are listed as a summary finding list of six items. The list shows the defects' location, type, severity, classification, and repair recommendation, depicted in Figure 3. Also, a detailed description of each defect is listed in a table format showing the defect location on the generated 3D reality model created by image mapping and a 3D modeling tool, and a close-range photograph of the specific defect along with the details. Unsafe and safe defect types are depicted in Figures 4 and 5, respectively.

In this case, a total of six defects were found. One was labeled as unsafe and immediate repair required, one was safe, and repair needed, and four defects were considered safe, with no attention required. This defect was found to be a potential risk of falling, which may endanger the public's safety. Apart from this one finding, the façade was in excellent condition overall. The report concluded that the façade contains a minimal number of defects that will render it at risk of producing falling objects. Remedial work is required to restore the structural integrity of the façade to full confidence in safety.

Once all images have been through the various image analytics, images are put through ContextCapture software to piece together and generate a 3D model. The generated model, therefore, becomes a digital twin of the building under inspection, allowing users to navigate and visually see the exact condition of the building and its facades during the point at which the images were captured. This enables users to identify the defects that require immediate attention and, likewise, other defects that can be considered low severity and need not be attended to immediately (Figures 4 and 5).

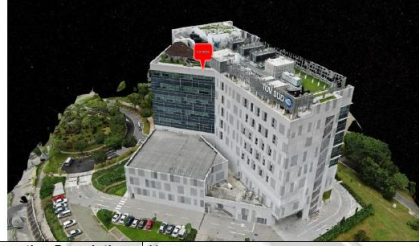
Defect Index	5
Defect Location

Defect Location Description	None
Defect Photo

Defect Type	Stain
Defect Description	Sealant Staining observed
Defect Classification	Safe
Recommended Action	No attention required
Repair Recommendation (Refer to Appendix A)	Aluminium,

Figure 5. Defect No.2 detail depiction (safe).

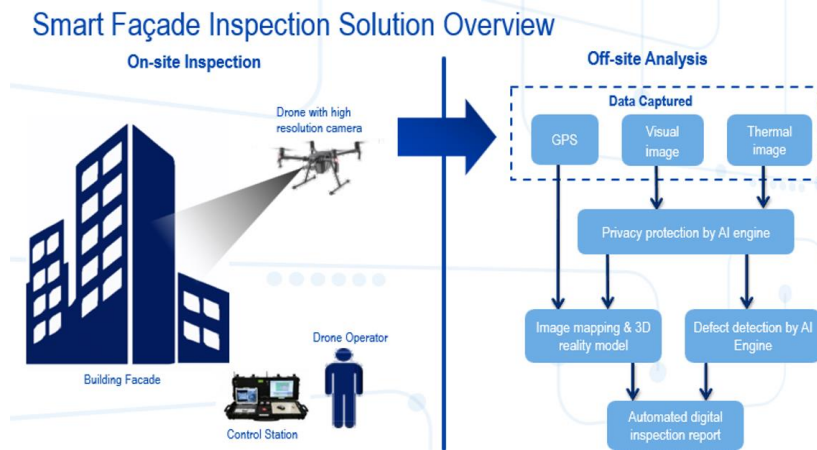
The Smart Façade Inspection execution process consists of an on-site inspection and off-site analysis (Figure 7). During the on-site inspection, the drone team arrives at the inspection site and confirms the documentation and risk assessment. It then sets up the equipment and secures take-off and landing zones. After confirming the flight plan and calibrating an auto-navigation system, it executes the inspection flight. Data is encrypted and securely transferred to the SFI platform. During the off-site analysis, captured data is converted into a 3D reality model and processed through AI algorithms. Inspection results and a 3D model are then available on the secure TÜV SÜD Smart Façade Inspection (SFI) data platform.

**Figure 7.** Smart Façade Inspection execution.
